M & M Consultants
Consultants Report

MAD RIVER: 1850-1925
THE EFFECTS OF FLOOD EVENTS
&
LAND USE ON SEDIMENT TRANSPORT PROCESSES

Presented to:
Humboldt County Department of Planning
3015 H Street
Eureka, CA.
for Mad River Gravel EIR, 1993

March 31, 1993

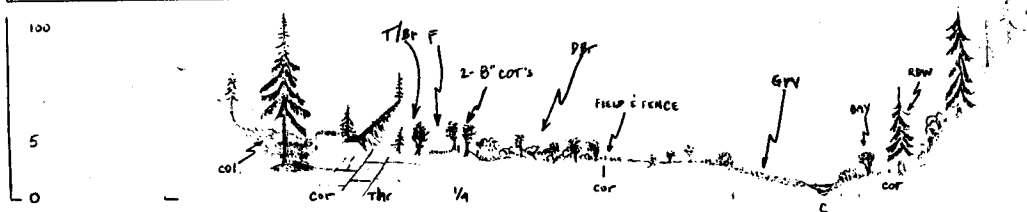
/usr2/ape/dtco/dgn/land_riv.dgn Mar. 26. 1993 10:46:18 Blue Lake Valley 1874

Diagrammatic cross sectional view, west to east along the southern border of sections 25, 30, 29 and 28.

T/Br = timber & brush	Grv = gravel
Thr = Thrust fault	Rdw = redwood
D.Br = dense brush	Col = colluvium

- a. Land steep, hill broken by tributaries of Mad River. Pine, cedar, bay, oak, fir.
- a'. On river bottom. Undergrowth dense oak brush.
- b. Timber redwood, cottonwood, pepperwood, pine, hazel & salmon brush.
- b'. Brush and timber
- c. Land level, soil 1st rate. Redwood, cottonwood, pepperwood, hazel, salmon brush.
- d. Land level, soil 1st rate. Redwood, maple, pine.
- e. Waste land of river bed. No timber.
- e'. Timber- redwood, pepperwood.
- f. Timber & brush (T/Br).
